# GENERAL BUILDING INSPECTION REPORT

935 Denny Lane, Ithaca, NY 14850

December 2, 2008

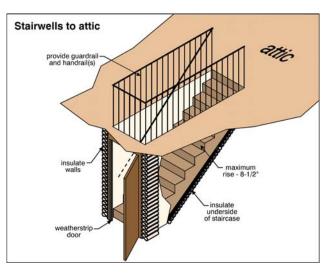
**Condition:** There are no railings provided at the attic area.

Comments: Recommend correcting the conditions noted for safety.

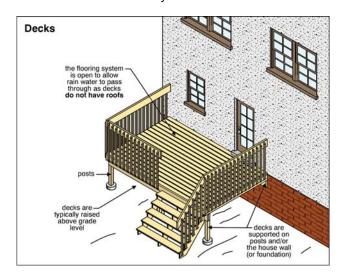
Condition: Improperly spaced railings noted.

Access to deck underside is blocked. viewing was possible only from below steps.

Comments: Recommend correcting the conditions noted for safety.

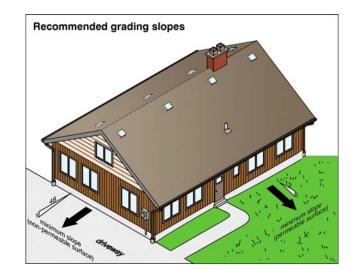
Condition: Pitch of slope is slightly toward foundation at the driveway, under deck, and at some areas to the left. Slope should fall away from the foundation at a minimum of 1/2 inch per foot and extend at least 10 feet away from the foundation for proper

drainage.

Comments: Monitor and correct conditions as needed.

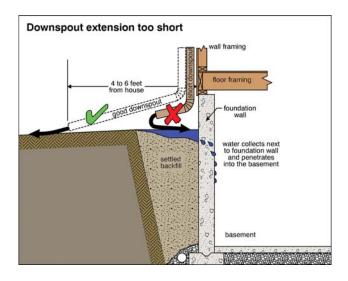
Condition: Downspout extension is too short at the front right, recommend extending further

from building to route water an adequate distance from the foundation area.

**Comments:** Recommend correcting the conditions noted for proper operation.
